AM Machinery inspection certificate

Claas Jaguar 830

#23148

AM INSPECTION CERTIFICATE

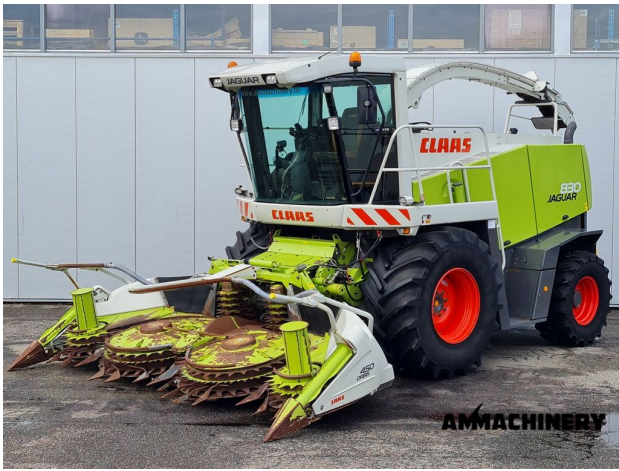
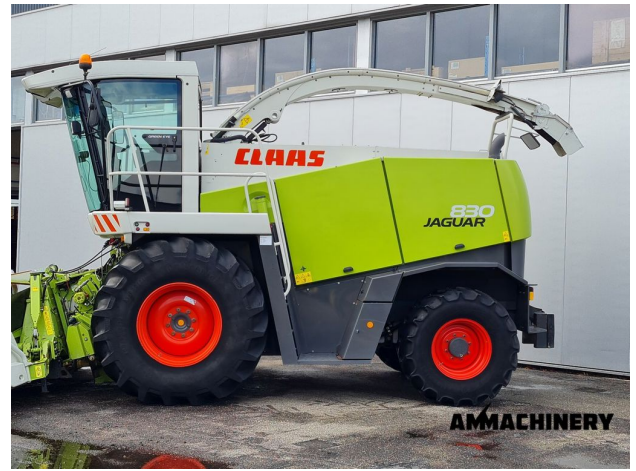
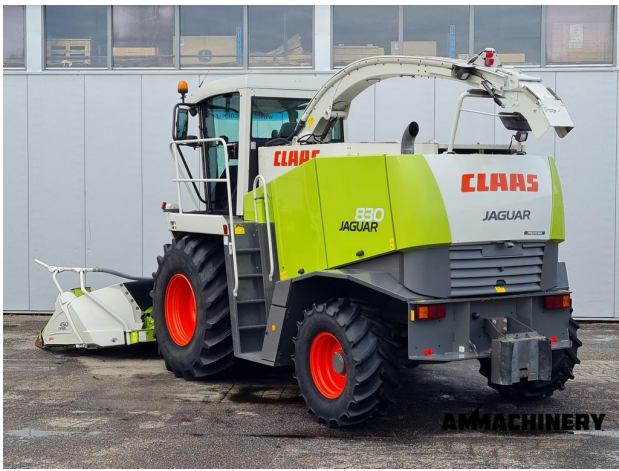
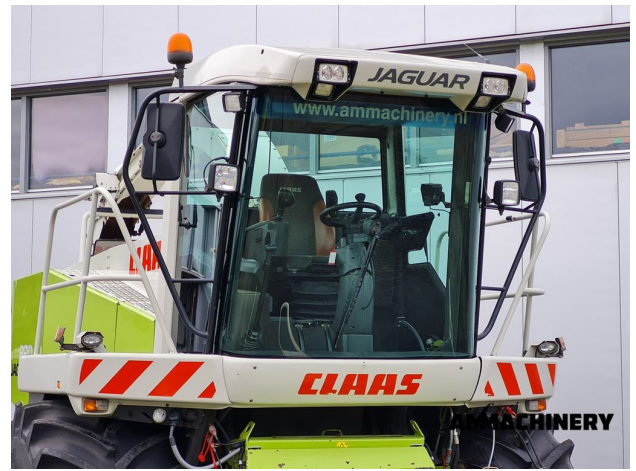
3) Product Images

For Sale 2013 Claas Jaguar 830 including Claas Orbis 450. 2646 engine hours, 1905 drum hours. 4WD, airconditioning, auto lubrication and kernel processor. This machine has been inspected on 300 points. The inspection report can be downloaded from our website. In addition, we provide a warranty on all our machines. For more information please send us a message.
